trivum troubleshooting

Troubleshooting

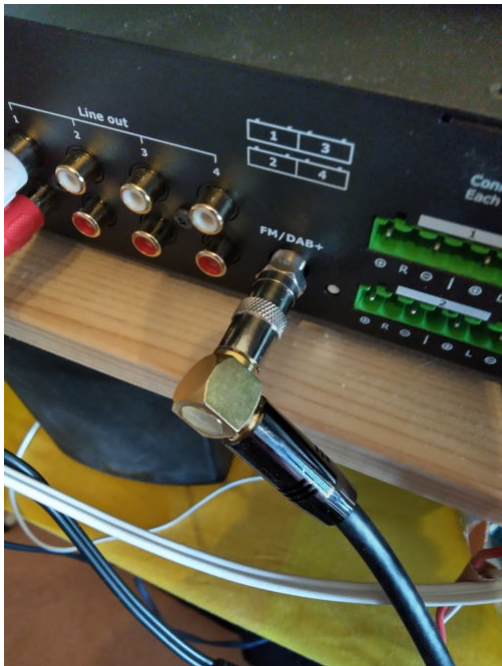
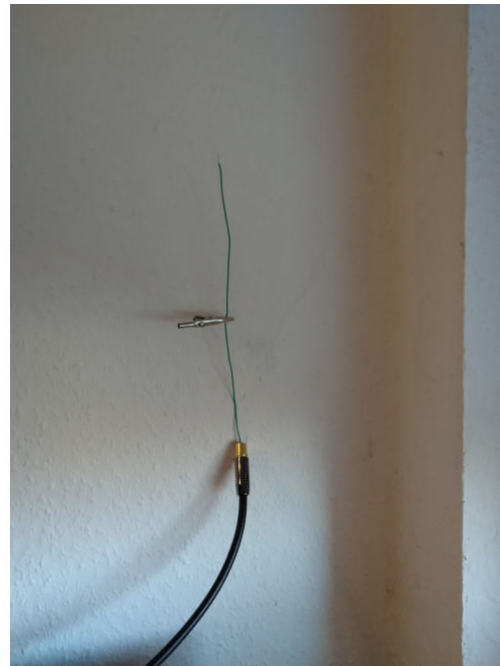
- get a 2m or longer shielded antenna cable, and suitable adapters. connect that to the SC344m antenna connector.
- at the other side of the cable, several meters away from the SC344m, connect your simple wire, or a throw antenna. This should be sufficient at living room level or higher.

- if your SC344m is located in a basement, you will have to connect the SC344m to an external antenna, or take a long antenna cable up to higher levels in your house, where you connect a wire or throw antenna.
